INFORMATION REPORT

COUNTRY	Poland	REPORT	
SUBJECT	Naval Base at Oksywie-Gdynia	DATE DISTR.	26 July 1954
		NO. OF PAGES	7
DATE OF INFO.		REQUIREMENT NO.	RD 25X1
PLACE ACQUIRED		REFERENCES

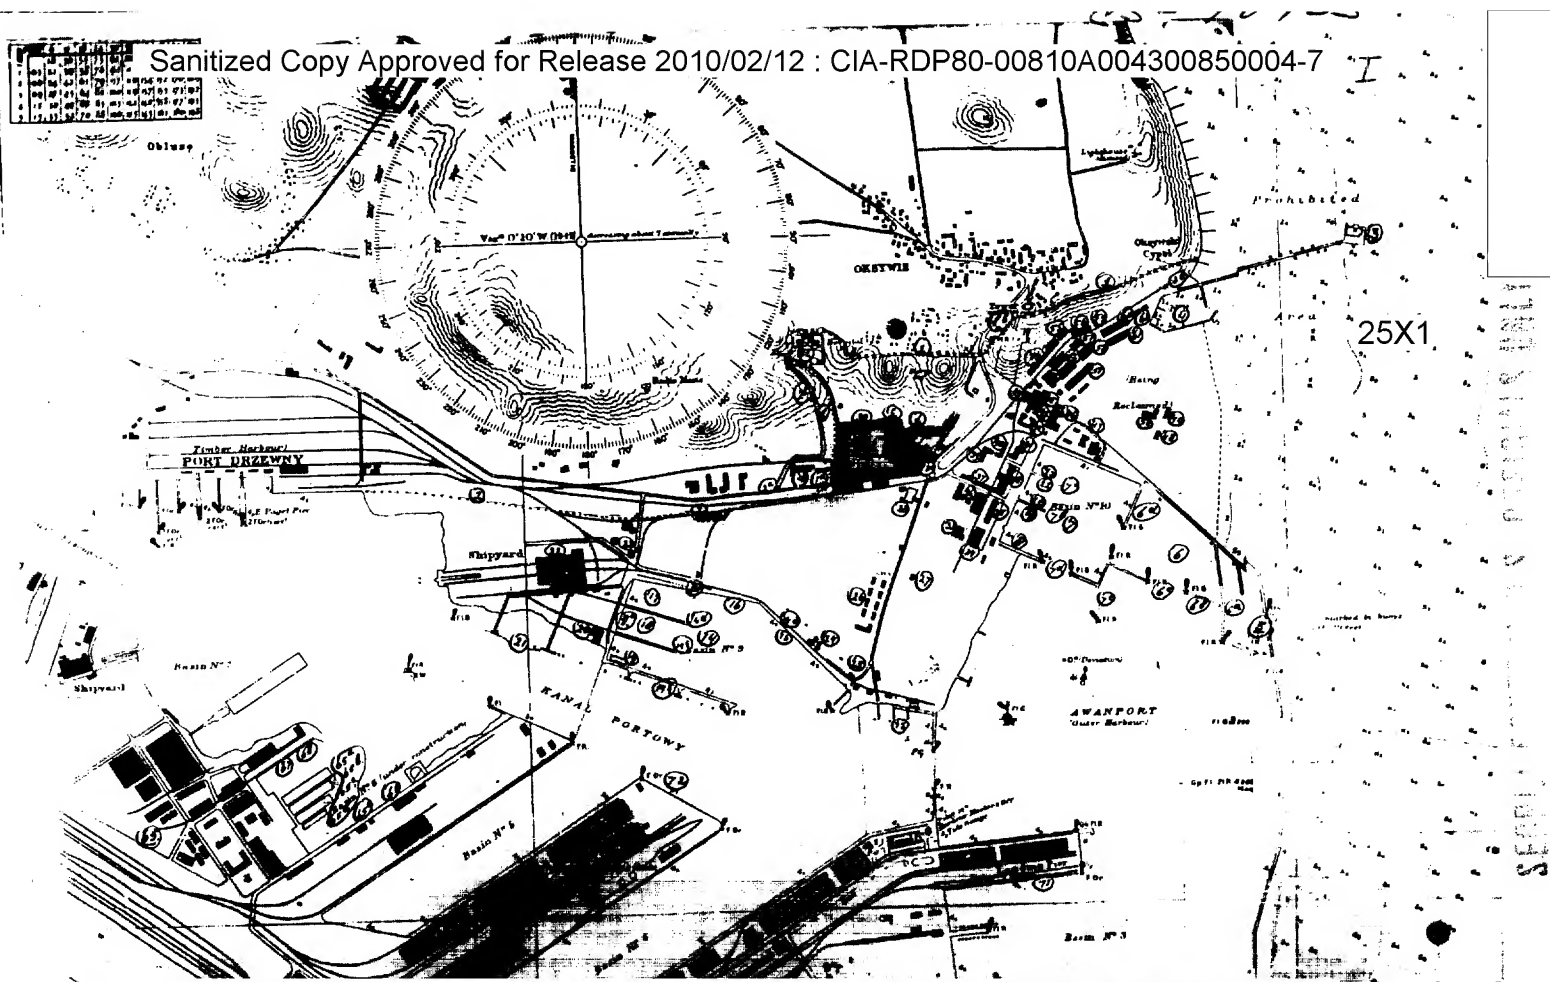
Legend to
~~Object Index for Chart of Gdynia Harbor~~

1. Boundry line of the Polish Naval Base
- 123 ^{Water}
2. ~~Station~~ ^{Railroad}
- 2a Street
- 2b ^{path around naval base} ~~Sidewalk~~ along the ~~barracks~~ grounds

3. Pier with "Formosa" bunker at extreme end
4. Basin
5. Present harbor entrance
6. New basin → 6a, 6b, 6c, 6d, Concrete piers
7. Basin No 10 → 6e Entrance to #6.

- 8a, 7b Wooden piers
- 7c, 7d Small concrete piers
- 7d, 7e Entrance to ~~the~~ basin no. 10
- 8, 9 Berth for ^{four} ~~4~~ to 5 Polish motor speed boats

- 10, 11 Berths for three submarines
12. Berths for ^{six} ~~6~~ minesweepers
13. ^{three} ~~3~~ wooden piers, of which ^{two} ~~2~~ are destroyed
14. Basin No 9 → 14a Quay
